## COMPLICATED SIPHON REHAB CHALLENGES PRE-JOB PLANNING PROCESS

Greg Smith, Manager of Coatings

Coblaco Services, Inc.

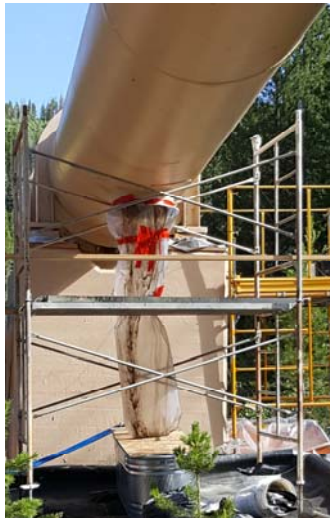
The potential of lead content inside the siphon was a noted concern as well. As a result, containing 100% of the waste became a key component to the successful removal of the interior coal-tar lining. The GC worked on the removal and replacement of all seven expansion joints on the line during the same timeframe that the coating repairs needed to be completed. This further complicated the task of controlling, capturing and segregating the waste streams.

**Spent lining waste funneled out of siphon**

In managing the waste, the solids were separated from the liquid stream to limit the quantities of potentially hazardous waste. The contractor's technicians designed a funnel and filtration system

to channel spent materials into separate receptacles outside the siphon. The contractor partnered with safety consultants and an industrial hygienist to ensure that a proper material disposal plan would be in place. Ultimately, the waste was tested and found to be non-hazardous.

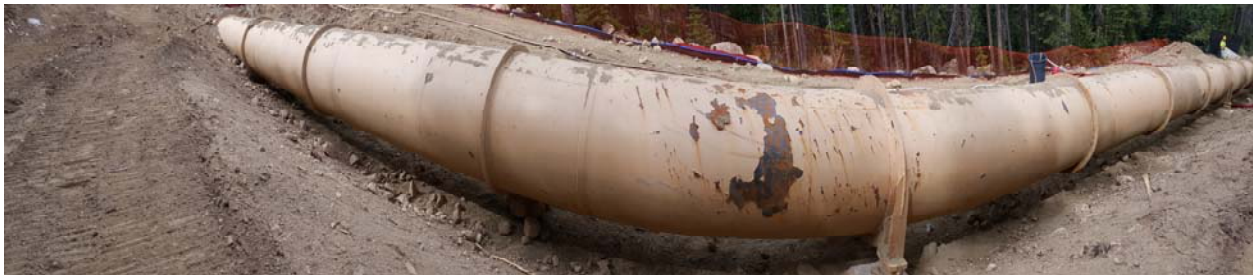
**Buried pipeline had been excavated to expose corrosion and allow for repair work**

The degree of corrosion was first thought to be significantly more in these sections of the pipe, so the owner specified a wax tape system, rather than traditional preparation and application of liquid coatings, again due primarily to the presence of lead primer. Following the excavation, some areas with significant coating failures were noted, however, many other areas were in much better condition. A previously-buried large section of the pipe that was immediately adjacent to a very popular hiking trail was surprisingly found to be intact. These sections were determined to be in good enough condition for the exterior repair procedure, (surface prepared per SSPC SP2 and SSPC SP1). Moreover, an application of an epoxy/polyurethane system could be utilized in lieu of the specified wax tape. Finally, all surface prep debris had to be captured, tested and disposed of appropriately, due to the lead-based primer.

methods and materials. The interior filler was changed to an additional coat of 100% solids material, offering faster production and a better overall schedule, while providing the necessary additional protection. The application of wax tape to all areas that had been buried was changed to spot repair and full overcoat, offering significant savings on both time and money, while at the same time, providing a better aesthetic finish in a highly-visible section of the pipe.
