# **Internal Joint Bonding of Prestressed Concrete Cylinder Pipe: The Improbable Project**

## **ABSTRACT**

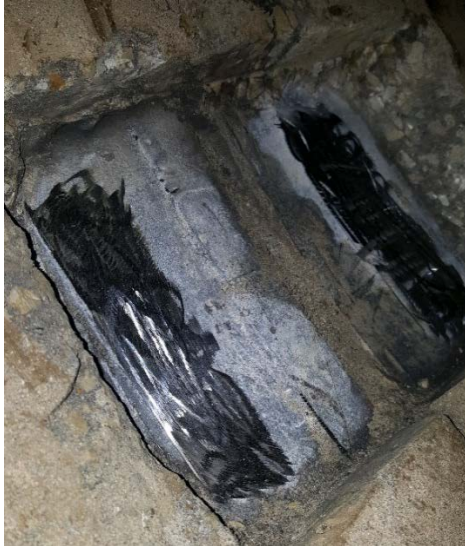
Figure 2. Exposed & Cleaned Joint

Once the pipe was dry and ventilated, the bonding crew was split into three entry teams ranging from 5 - 8 technicians, with an additional team handling logistical support outside the pipe. The teams worked in an assembly line fashion, first cutting 12-inch by 10-inch 'windows' over each joint at the 5 o'clock to 7 o'clock position, using saws with depth guides set to 1/8-inch shy of the determined thickness of the concrete. Then the concrete would have to be chiseled out using power chipping tools, and the debris had to be cleaned up to ensure efficient travel through the pipe. Once the concrete had been removed down to the bare metal cylinder (see Figure 2), the steel was cleaned with power tools to remove all mill scale, corrosion and debris. Next three 8-inch No. 4 American Wire Gauge (AWG) wires were installed across each joint of pipe with a thermite weld attaching each end of the copper wire to the cylinder and spigot ring (see Figure 3). After each end of the three wires had been secured across each joint of pipe, quality control testing was complete using a low resistance ohmmeter, to measure the electrical continuity of each joint following bonding (see Figure 4). After verification of the required continuity was made a moisture-resistant fast cure epoxy was applied over all exposed copper wire and thermite welds to protect against any future corrosion. After the epoxy had been applied and allowed time to cure, the concrete cutout was replaced by a cement and sand grout mixture. To ensure continuity across the pipeline, testing was completed from each of the test stations that had been installed, and a lineal pipe resistance (LPR) continuity calculation was completed by the corrosion engineer verifying an electrically continuous pipeline.

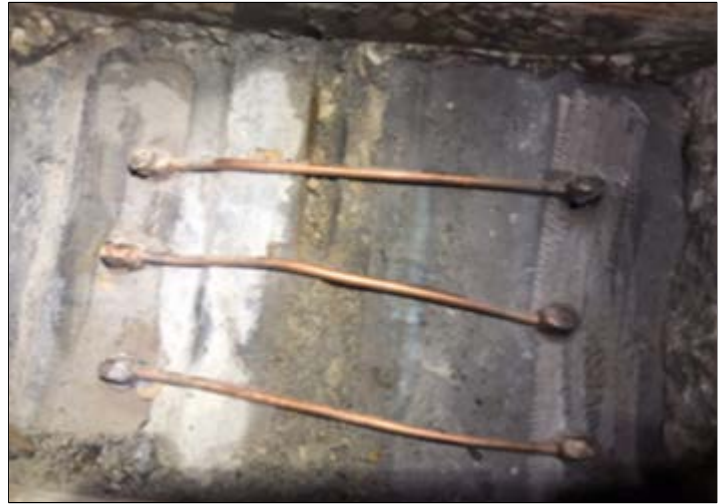
Figure 3. No.4 AWG Wires Thermite Welded

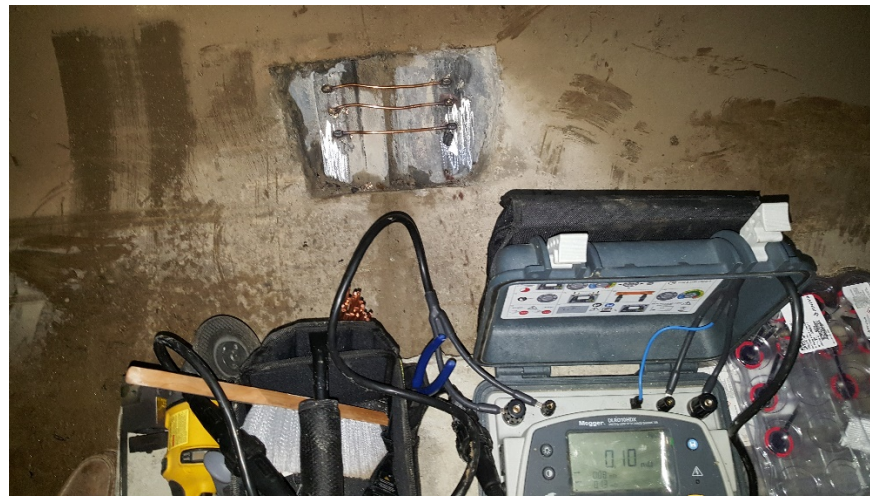
Figure 4. Resistance Measurement
